Results from Preliminary Checks on AmBe Neutron Source #71

DSTO-TN-1003

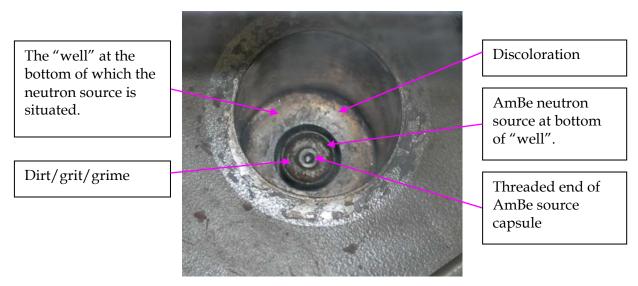
Figure 12. AmBe source within the opened transport container (photographed using angled mirror)

Figure 12 is a photograph taken using the angled mirror (refer to Figure 8 in section 3.1) which shows a view down into the transport container "well" once the plug insert had been removed. The AmBe source can be seen at the bottom of the well. The source capsule has a threaded end that attaches to the handling rod.

There were no obvious cracks in the source capsule, no signs of corrosion, nor any obvious leakage of material.

Two wipe samples were collected. The first by wiping the bottom of the source container plug and the second by wiping the top of the source (shown in Figure 12) and inside of the transport container using the U-shaped remote handling tool. Table 5 summarises the results from these two 2 wipe samples. Both wipe samples had on them what can be described as dirt, grit and grime that was black/grey in colour. There were no obvious rust-like stains on either of the wipe samples to indicate that corrosion had occurred.

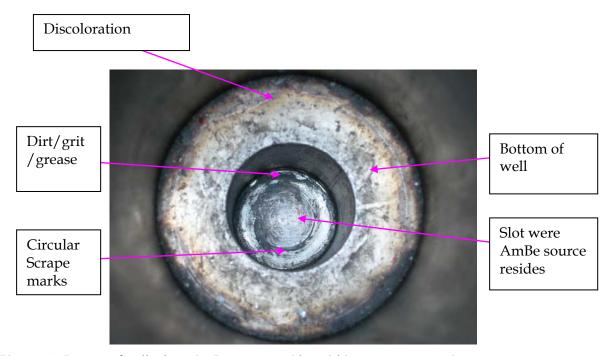
Figure 13. Bottom of well where AmBe source resides within transport container

- a. some discoloration or tarnishing of the metal;
- b. presence of dirt/grit/grime/dried grease (this is what was picked up when collecting wipe samples); and
- c. circular scrape marks due to the fact that when attaching the AmBe source capsule to the handling rod the capsule undergoes some rotation while downward pressure is applied with the handling rod.

The discoloration or tarnishing noted in Figure 13 is likely to be due to the formation of an oxide layer on the surface of the metal which may assist with preserving the underlying metal.

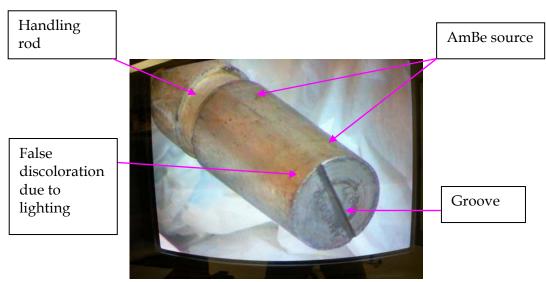
Figure 14. AmBe source (0° position)

The source capsule showed signs of wear and tear from past use. Circular scrape marks could be seen on the bottom end of the capsule. The capsule had some discoloration, though the yellow-like colour observed in figures 14-16 was exaggerated and was due to the quality of the ambient lighting and use of a fluorescent lamp and the fact that the images were viewed on a CCTV screen. The bottom end of the source capsule in the above figures gives an indication of its true colour. This true colour was visually observed when using the angled mirror shown in Figure 17.

There were no obvious signs of corrosion, cracks or fissures from the visual inspection performed using CCTV. No obvious leakage of material was observed during the inspection process. Overall, the source capsule appeared to be in reasonable condition for continued use.

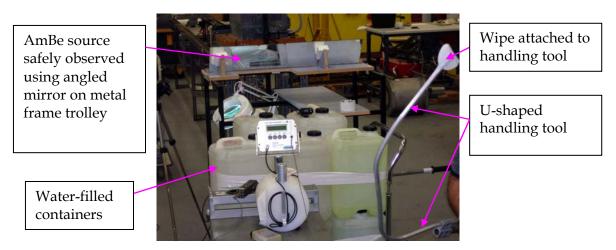
Figure 17. Wiping the AmBe neutron source using wipe attached to U-shaped remote handling tool

Figure 17 shows the use of a wipe attached to a U-shaped remote handling tool to wipe the surface of the AmBe source. The wiping process was performed by standing behind the safety of the "wall of water" and using the angled mirror to safely view the AmBe neutron source.

Similar to the previous wipe samples, the three wipe samples described in Table 7 had on them what can be described as dirt, grit and grime that was black/grey in colour. There was no rust-like stain on any of the wipe samples to indicate that corrosion had occurred.
